NATIONAL ADVISORY COMMITTEE FOR AERONAUTICS

TIDEWATER AND WEATHER-EXPOSURE TESTS ON METALS

USED IN AIRCRAFT - II

TECHNICAL NOTE No. 842

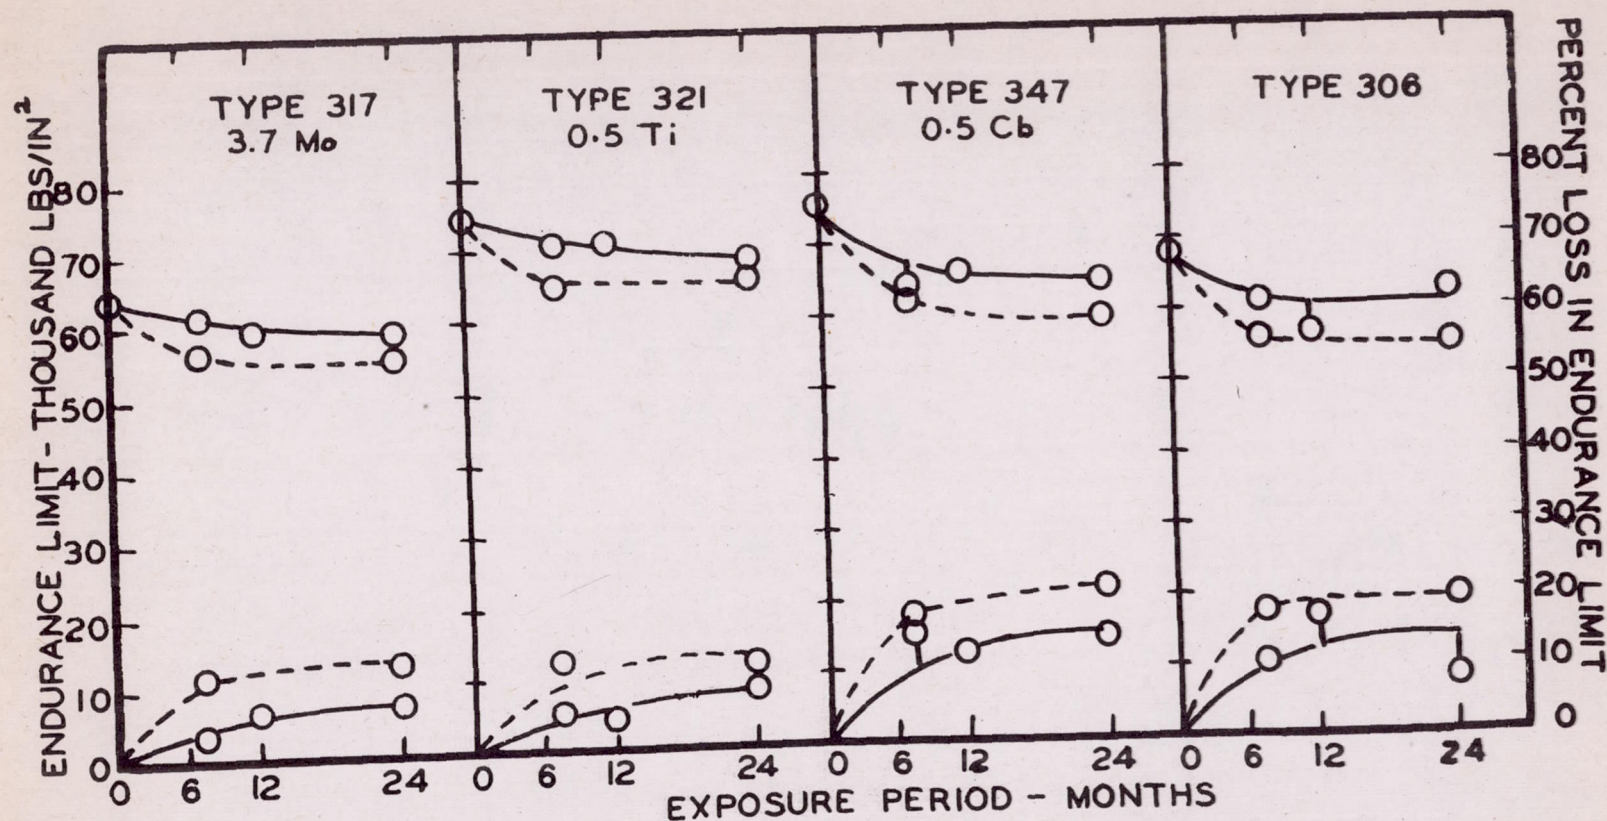
The endurance limits of some 300 specimens have been determined since reference 1 was released, both on panels as received (uncorroded) or on panels removed from the exposure racks during the first 2 years. The endurance limit values reported may be regarded as accurate only insofar as they serve to present a basis of comparison between the alloys tested. The values given (fig. 32 and table III) represent a stress, the half range of which was calculated to be within 800 pounds per square inch of the next highest stress, which resulted in fatigue failure, provided that at least two runs past 10^6 cycles had been made.

Figure 32.- Results of flexural fatigue tests on stainless steel. Solid line curves pertain to specimens exposed to tidewater; broken-line curves pertain to specimens exposed to the weather. The upper curves, in each instance, refer to values for endurance limits; the lower curves to percentage loss. Panels exposed to the weather consistently showed greater loss than those exposed to tidewater for equal periods. Steels containing molybdenum or titanium exhibited appreciably lower losses than those with columbium, or with no elements added to the typical 18 percent chromium, 8 percent nickel alloy (Type 306).
